Preliminary Geotechnical Report

Preliminary Geotechnical Report
Avila Community Plan Update
San Luis Obispo County, California

Yeh Project No.: 218-514

December 31, 2020

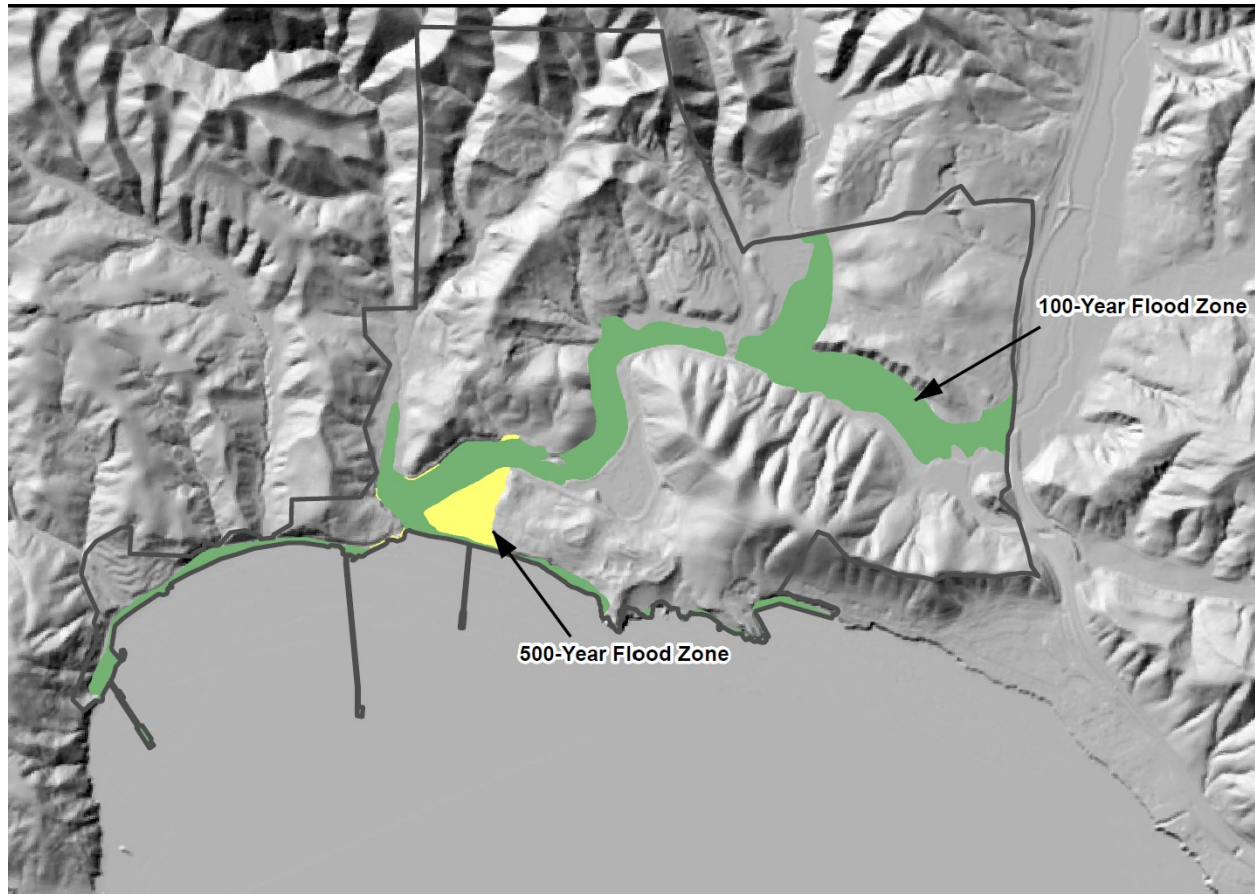
Figure 2: FEMA Flood Map; no scale

Figure 2 shows the FEMA (2020) 100-year and 500-year flood zones mapped in the vicinity of the Avila URL. Low-lying areas along See Canyon Creek, San Luis Obispo Creek, and along San Luis Bay are within the FEMA 100-year flood zone (1-percent annual chance of flood). The western half of the town of Avila is mapped within the 500-year flood hazard zone (0.2-percent annual chance of flood) at elevations of approximately 16 feet or lower (NAVD88). The 500-year flood hazard zone boundary is approximately 100 feet east of and parallel to San Miguel Street.

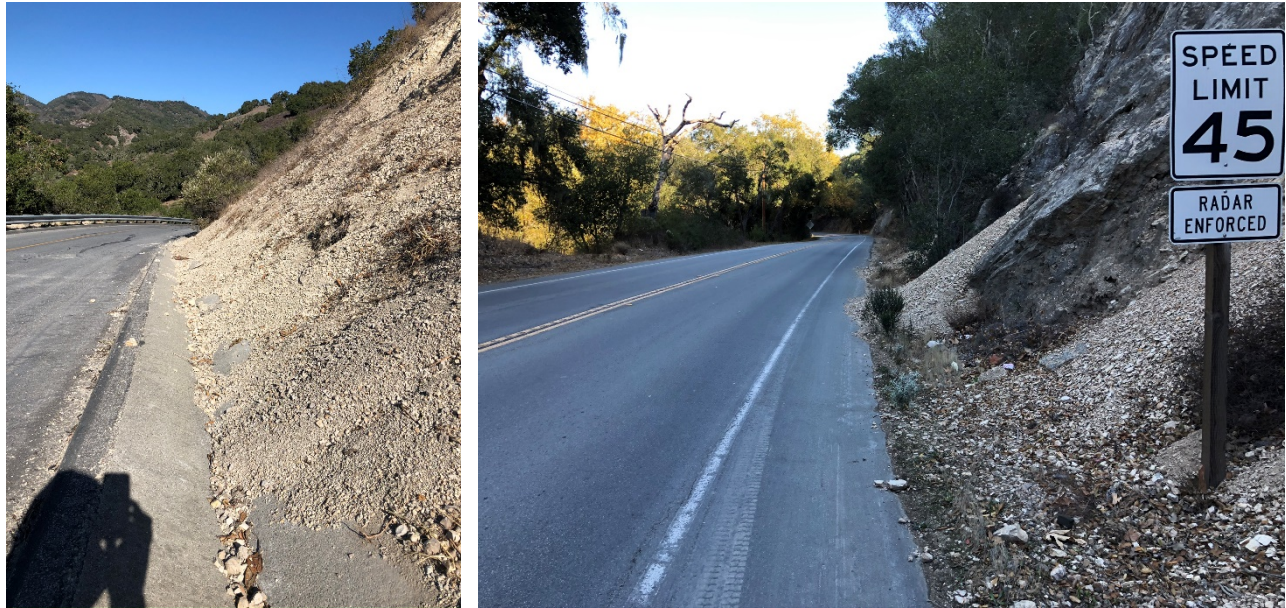
Figure 3: Sedimentation Photos

Eroded sediment in V-ditch on Lupine Canyon Road (left); talus in catchment along Avila Beach Road (right)

We observed evidence of erosion consisting of sediment and talus⁵ cones accumulating on and along the edge of roadways, including within v-ditches and catchments (see Figure 3). The sediment we observed typically consisted of silty sand (SM) and silty gravel (GM) derived from the Squire and Belleview Members of the Pismo Formation and the Monterey Shale. We also observed evidence of erosion along See Canyon Road consisting of a reduced roadway shoulder that likely resulted from bank erosion and incision along See Canyon Creek (see Figure 4).

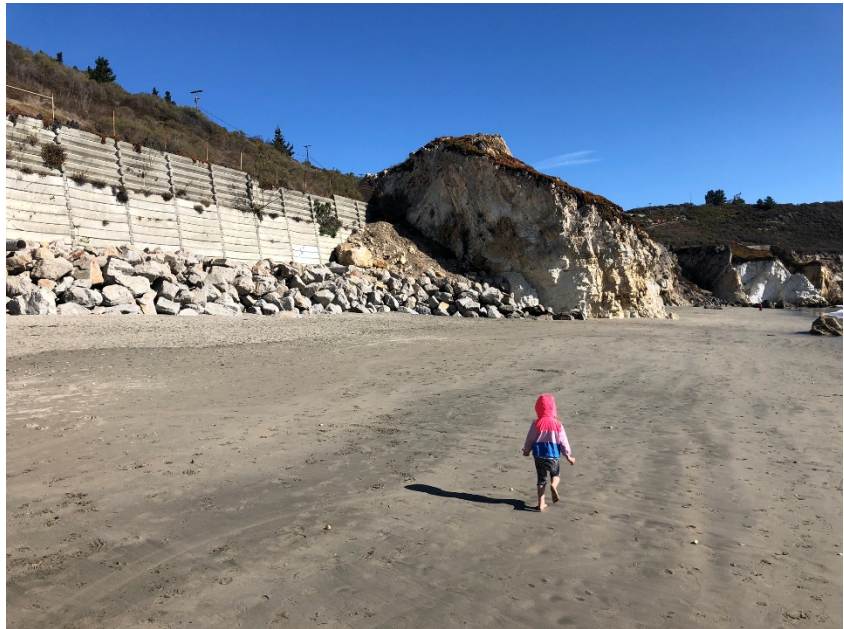
Figure 5: Rock Revetment along Avila Beach

Although most of Avila Beach is protected by 10 to 20-foot-high seawalls and rock revetment along Port San Luis and Front Street (see Figure 5), low-lying areas are potentially exposed to wave run-up and flooding. Avila Beach is partially sheltered from northerly swells by the Point San Luis Breakwater but is vulnerable to coastal storms originating from the southwest (County of SLO 2019b).

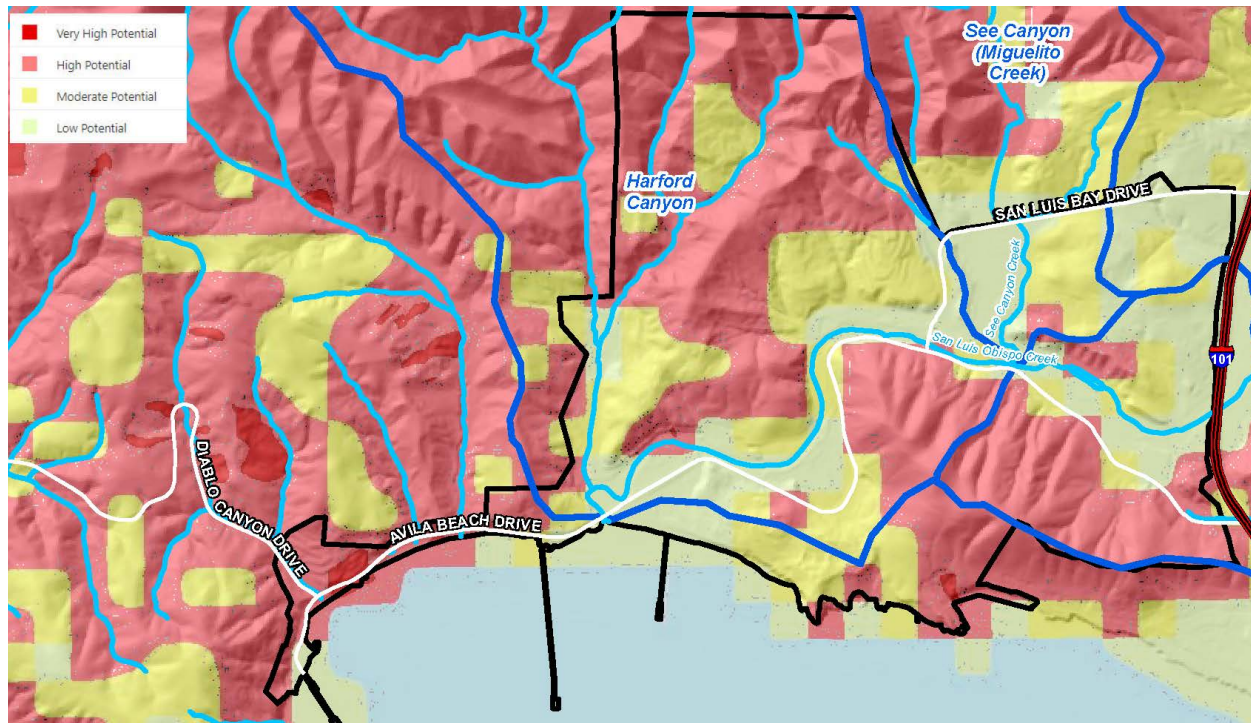
Figure 6: Landslide Risk Map (County of SLO 2020a); no scale

Figure 6 shows the County of SLO’s (2020a) map of landslide risk within the Avila URL. The potential for landslide risk predominantly ranges from low to high, according to the County’s rating system, which is predominantly rated based on existing slope grades and mapped geology. The County of SLO’s (2020a) map is intended to be used as a general guide for land use planning purposes only. It should not be considered as a substitute for performing appropriate geologic and geotechnical investigations, or a substitute for providing proper site design and engineering of individual projects. The potential for landslides was rated “very high” in the areas mapped as Quaternary landslides by published geologic maps (Hall 1979, Wiegers 2011) at Pirate’s Cove near Cave Landing Road and at the Harbor Terrace Development.
